Troubleshooting a Permanent Link

Introduction

Testing/Troubleshooting a Cassette to Cassette based system

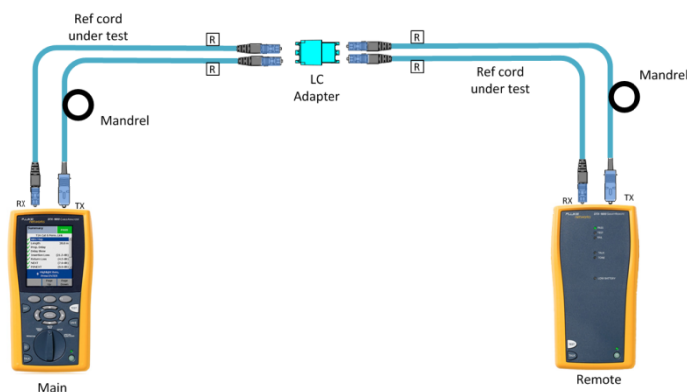
2. After referencing (Results between -22dB and -24dB). Add LC to LC reference cords and test them to ensure they are within the 0.15dB standard for IL.

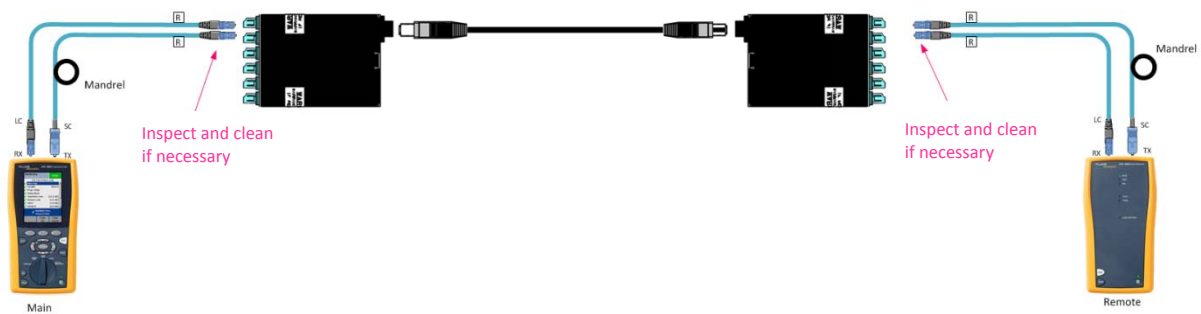
4. If link fails, inspect the LC endfaces of the reference cords that are mated to the cassettes, dry clean if necessary, re-inspect. Re-mate when clean and retest the link.

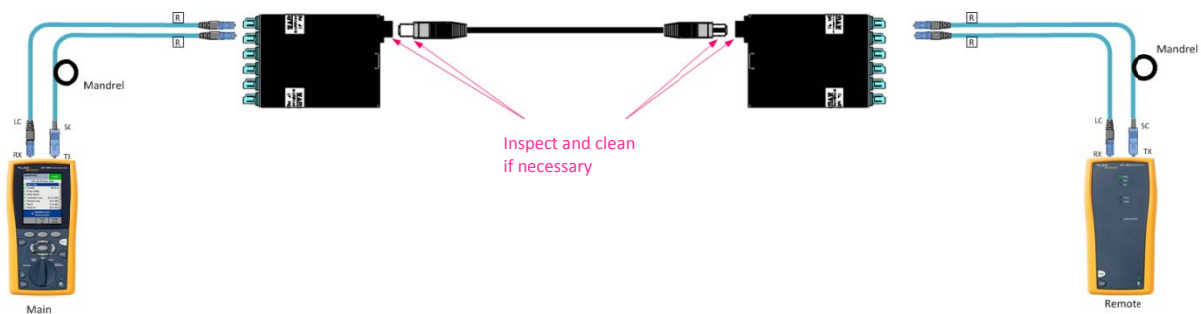
5. If the link fails, inspect the MPO endfaces of the trunk assembly attached to the cassettes and the endfaces of the MPO internal to the cassette. Dry clean if necessary, re-inspect and re-mate when clean. Retest the link.

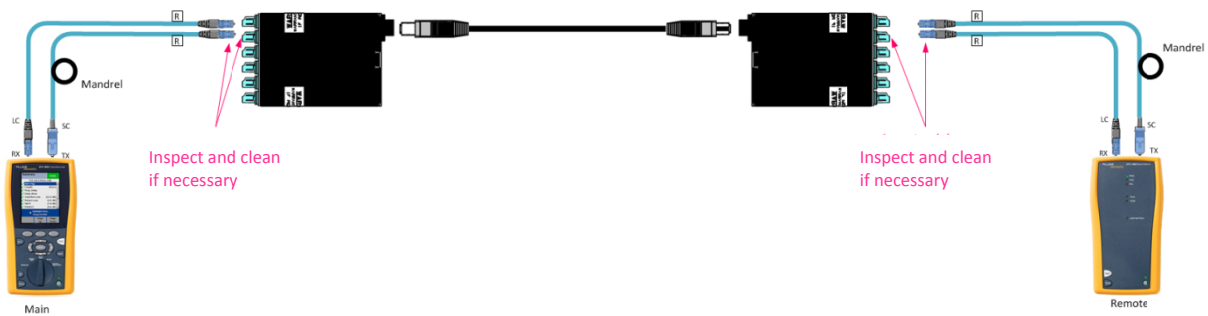
6. If the link fails, inspect the LC endfaces internal to the cassettes and re-inspect the endfaces of LC reference cords mated to the cassettes. Dry clean if necessary, re-inspect, re-mate when clean and retest the link.

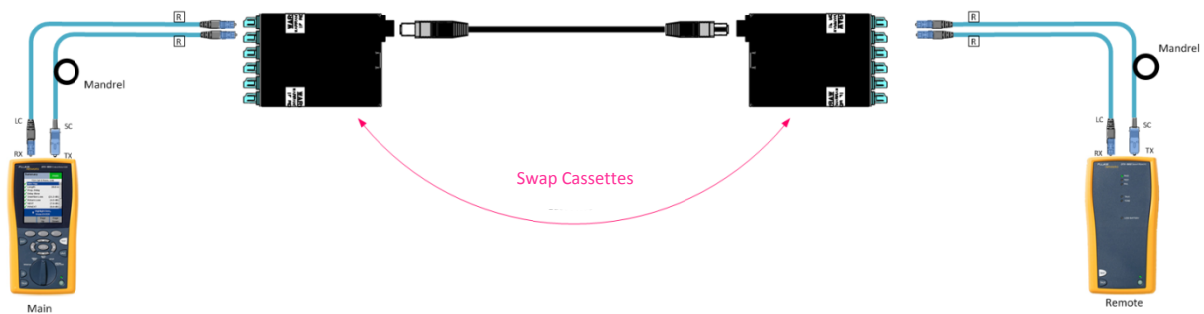
7. If the link fails, swap cassettes. If and retest.

8. If the failure follows the cassette, then you know the cassette is bad. If it doesn't then there is possibly something wrong with the MPO on the failed side of the link.
9. Either try a new cassette to ensure the endface mating between the cassette MPO and the horizontal cabling MPO was not the issue or you can try testing the MPO cabling solution with the Multi-Fiber Pro

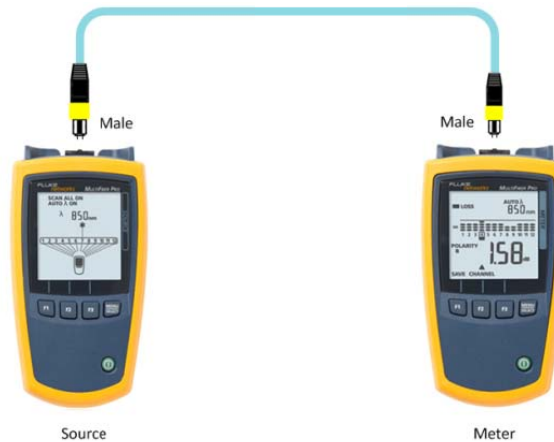
Setting
Reference

1. Reference utilizing Method B. (Note: The PanMPO will need to have male gender to interface with the Fluke Multi-Pro female interface).

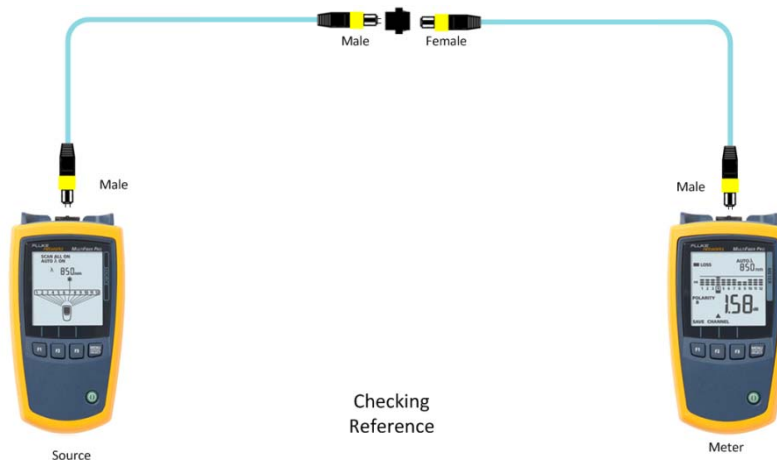
Checking
Reference

2. Test the MPO reference cord. This is completed by changing the one PanMPO reference cord end to female gender as shown.

Note: The reference value for all twelve channels shall be $\geq 0.25\text{dB}$ to ensure the MPO cable meets reference grade specifications.

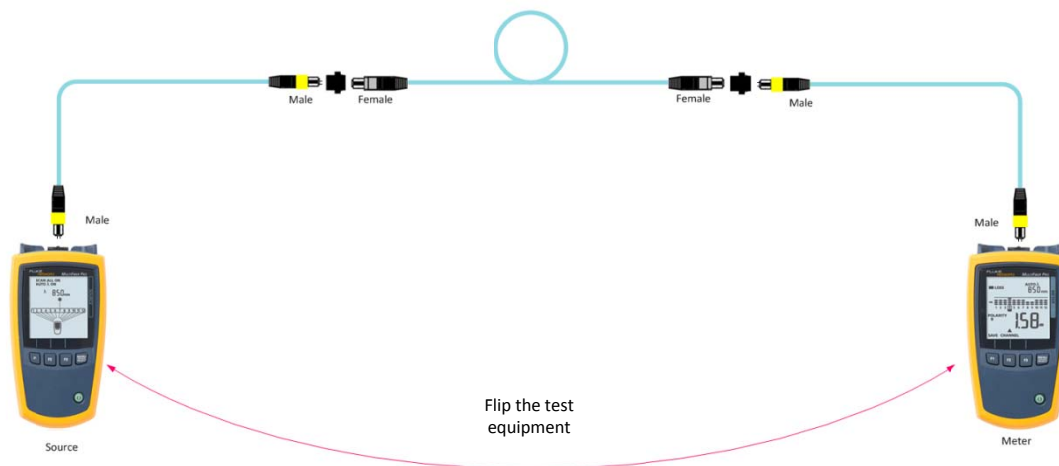
5. If the link fails, flip the Meter and Source and test from the other direction.

6. If the link fails, then there is an issue with either the MPO connector on the assembly or with the cable within the assembly. If it passes, there is an issue with the MPO connector on the first end tested and further troubleshooting needs to occur or the MPO needs to be replaced.
