Troubleshooting a Permanent Link

Introduction

Testing/Troubleshooting a Cassette to Cassette based system

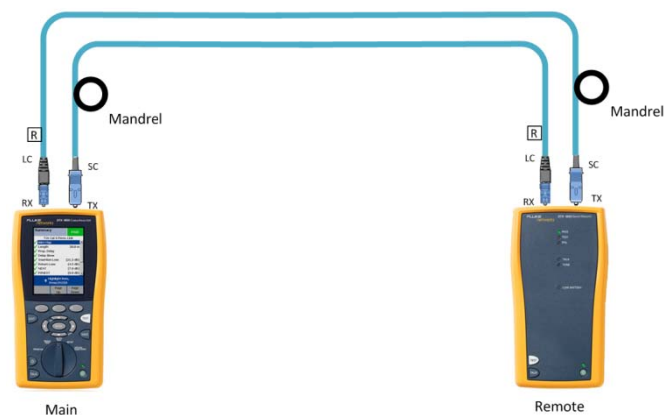
1. Reference utilizing method B (One Jumper Reference)

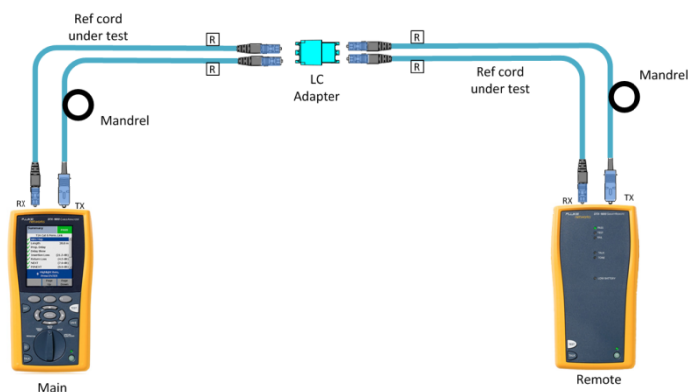
2. After referencing (Results between -22dB and -24dB). Add LC to LC reference cords and test them to ensure they are within the 0.15dB standard for IL.

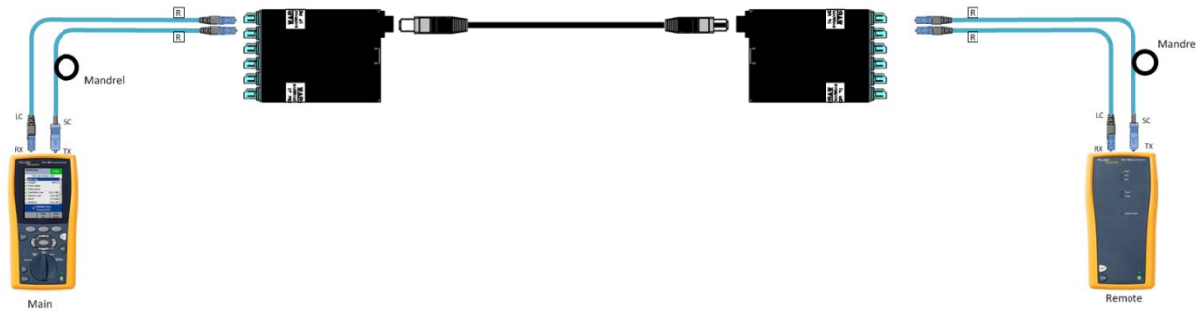
3. Test Link

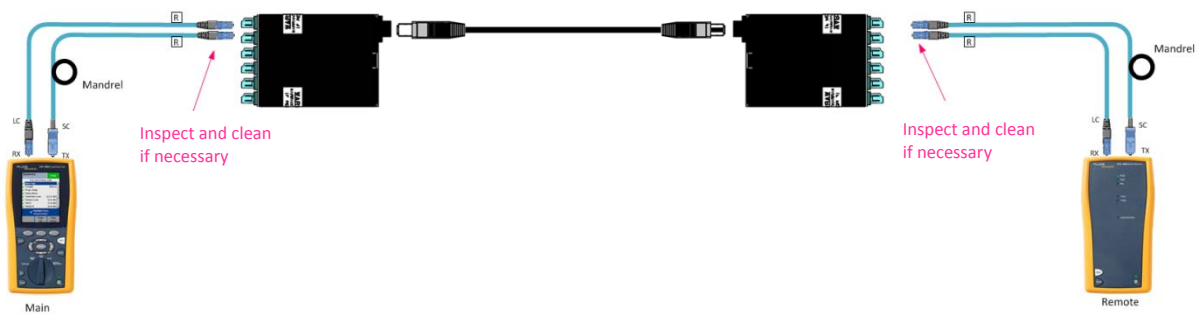
4. If link fails, inspect the LC endfaces of the reference cords that are mated to the cassettes, dry clean if necessary, re-inspect. Re-mate when clean and retest the link.

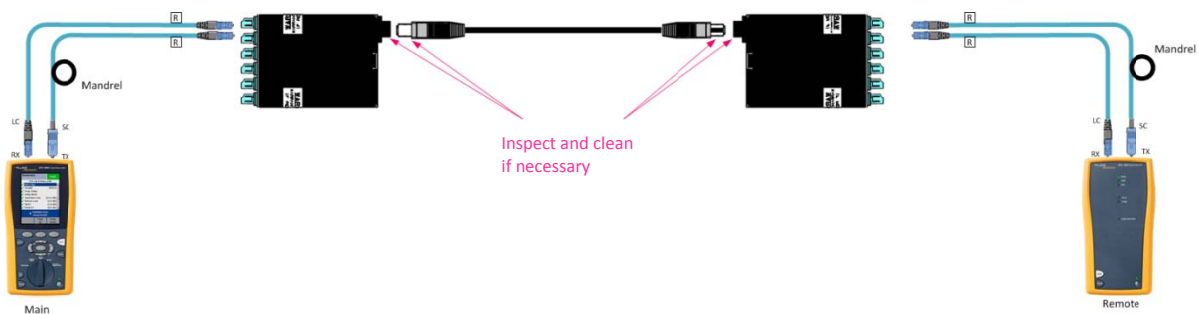
5. If the link fails, inspect the MPO endfaces of the trunk assembly attached to the cassettes and the endfaces of the MPO internal to the cassette. Dry clean if necessary, re-inspect and re-mate when clean. Retest the link.

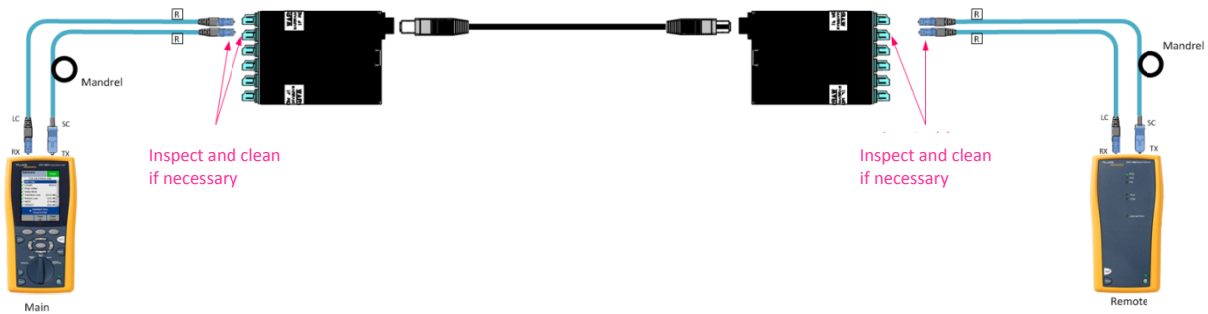
6. If the link fails, inspect the LC endfaces internal to the cassettes and re-inspect the endfaces of LC reference cords mated to the cassettes. Dry clean if necessary, re-inspect, re-mate when clean and retest the link.

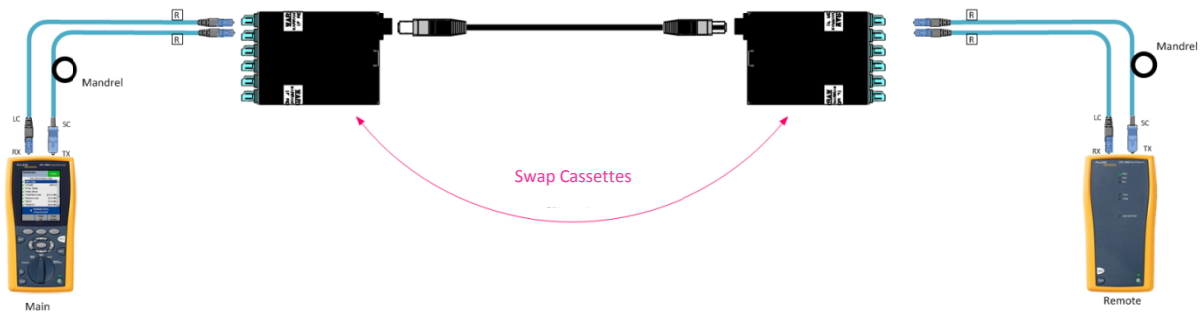
7. If the link fails, swap cassettes. If and retest.

8. If the failure follows the cassette, then you know the cassette is bad. If it doesn't then there is possibly something wrong with the MPO on the failed side of the link.
9. Either try a new cassette to ensure the endface mating between the cassette MPO and the horizontal cabling MPO was not the issue or you can try testing the MPO cabling solution with the Multi-Fiber Pro

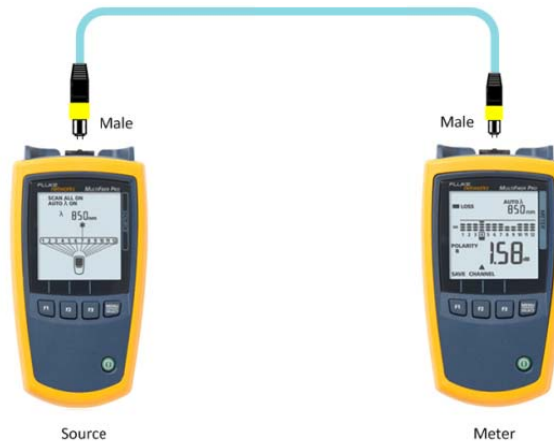
Setting
Reference

1. Reference utilizing Method B. (Note: The PanMPO will need to have male gender to interface with the Fluke Multi-Pro female interface).

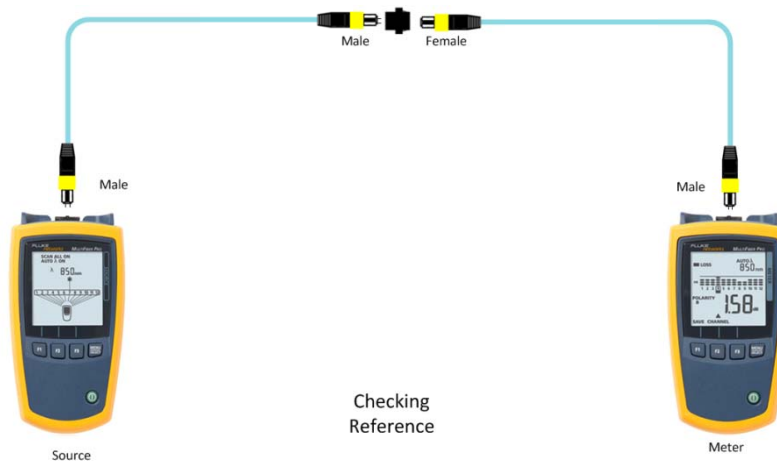
Checking
Reference

2. Test the MPO reference cord. This is completed by changing the one PanMPO reference cord end to female gender as shown.

Note: The reference value for all twelve channels shall be $\geq 0.25\text{dB}$ to ensure the MPO cable meets reference grade specifications.

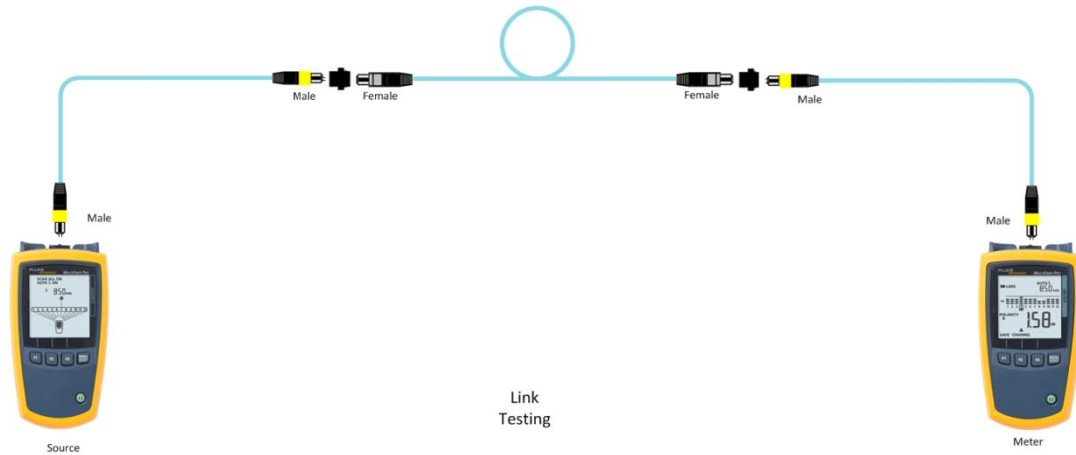
3. Test MPO horizontal cable as shown. Note that the Female PanMPO used in Step 2 to check the integrity of the reference cord has to be changed back to Male in order to test the link.

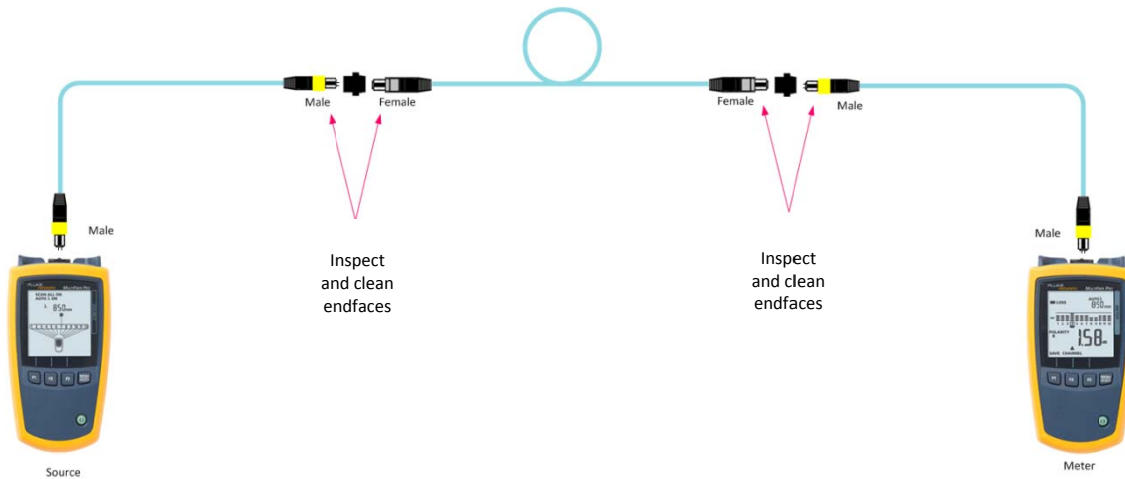
4. If the link fails, inspect all four endfaces and clean if necessary. Re-mate and retest.

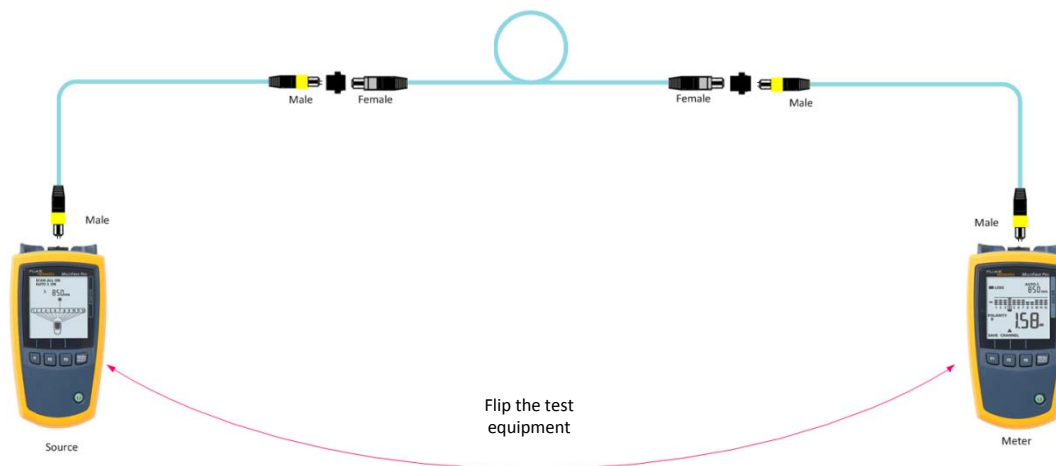
5. If the link fails, flip the Meter and Source and test from the other direction.

6. If the link fails, then there is an issue with either the MPO connector on the assembly or with the cable within the assembly. If it passes, there is an issue with the MPO connector on the first end tested and further troubleshooting needs to occur or the MPO needs to be replaced.
