Troubleshooting a Permanent Link

Introduction

Testing/Troubleshooting a Cassette to Cassette based system

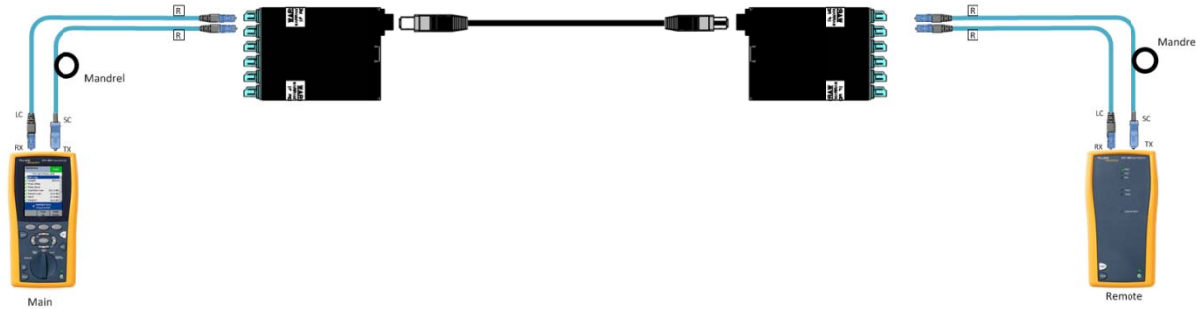
3. Test Link

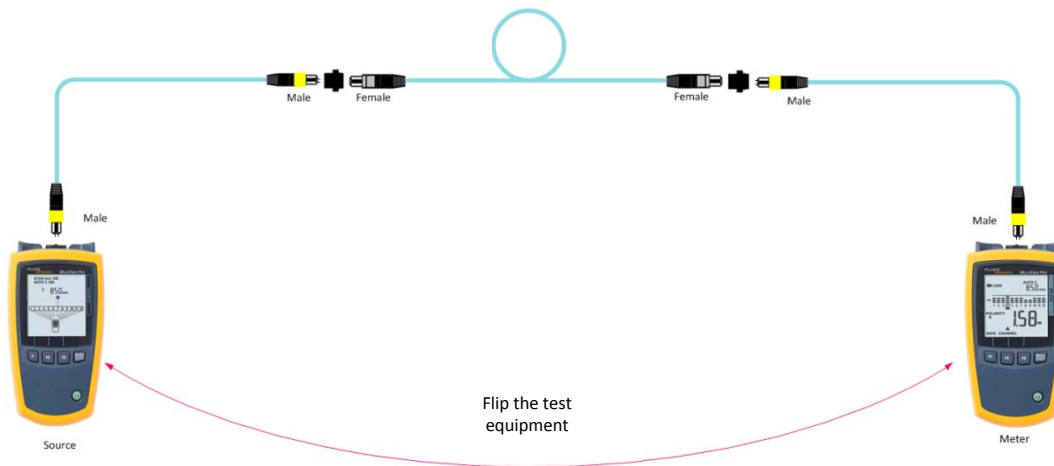
5. If the link fails, flip the Meter and Source and test from the other direction.

6. If the link fails, then there is an issue with either the MPO connector on the assembly or with the cable within the assembly. If it passes, there is an issue with the MPO connector on the first end tested and further troubleshooting needs to occur or the MPO needs to be replaced.
