PVIQ Firmware Upgrade Procedures (Standalone)

Applies to:	SmartZone PVIQ Panels
Objective:	This Technical Reference describes the procedure to upgrade the firmware of PVIQ Panels that are operating in a standalone (i.e., without SmartZone software) environment.
Pre-Requisites:	<ul style="list-style-type: none"> • Ensure that 3COM TFTP Server(s) are installed (3COM TFTP Servers are required to ensure 30 concurrent downloads can be achieved) • Setup 1 TFTP server for every 30 PMs • The TFTP server must be connected to the same subnet as the PMs. • Allocate time for visual inspection (see step 1 below for detailed instructions) • Allocate time for the firmware downloads to start • It will be necessary to telnet into all PMs and enter commands

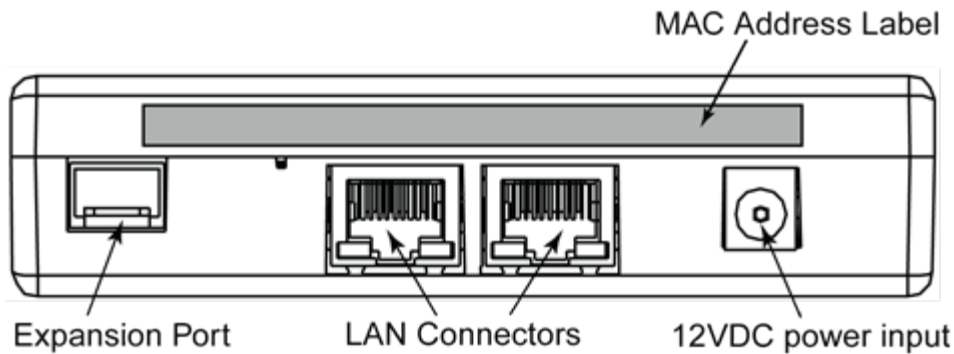
- Verify that all PMs are installed in PVIQ[™] Panels. The PMs **must** be in PVIQ Panels so that panel wing board firmware can be upgraded along with the PMs. Visually inspect the panels and verify that each displays a solid green “SYS” LED. Failure to follow this step may result in unexpected runtime errors.
- Ensure that the first PM has a link to the network.
- Ensure that each PM is connected to the next PM in the chain. The last PM must have only one connection.

NOTE: IF A NETWORK LOOP EXISTS THE YELLOW LIGHTS ON THE PM LAN CONNECTOR WILL BE SOLID YELLOW. IF THIS OCCURS, REPAIR THE LOOP! DO NOT CONTINUE, OTHERWISE PANEL DAMAGE WILL OCCUR!

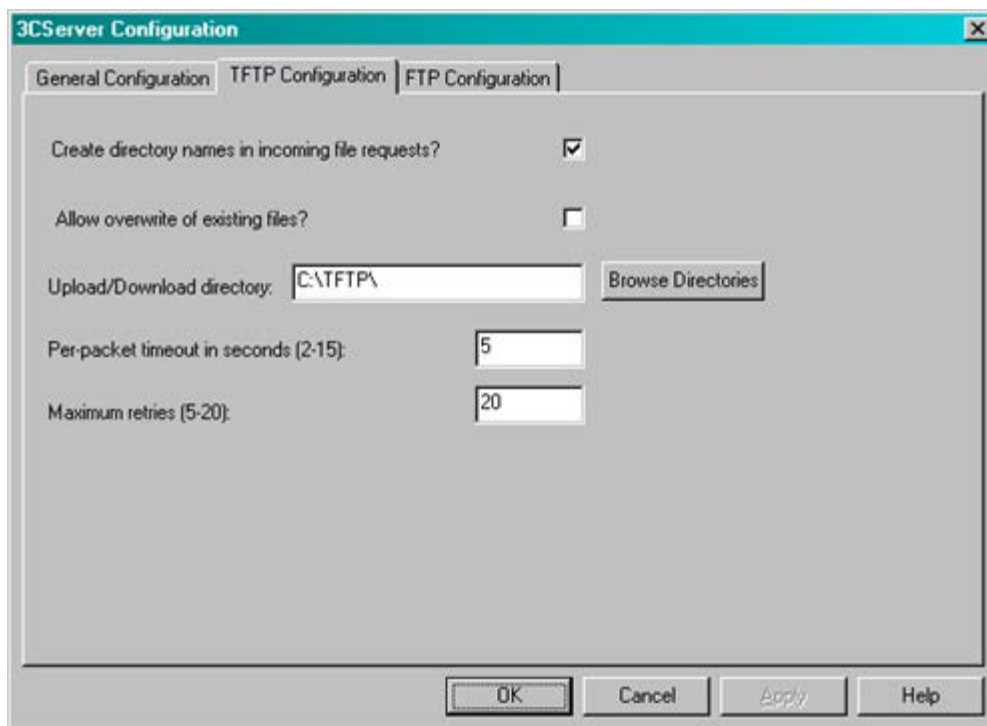
2. Setup the 3COM TFTP Server.

- Set the TFTP server parameters to 20 retries after 5 seconds.
- Set the TFTP server to serve files from the folder containing the firmware

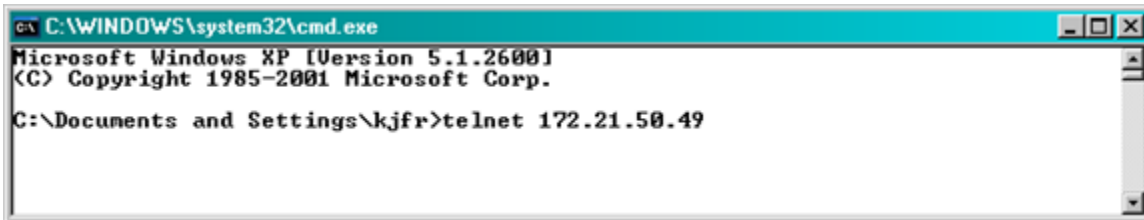
- Telnet into the PViQ device (for example, “telnet 172.21.50.49”).

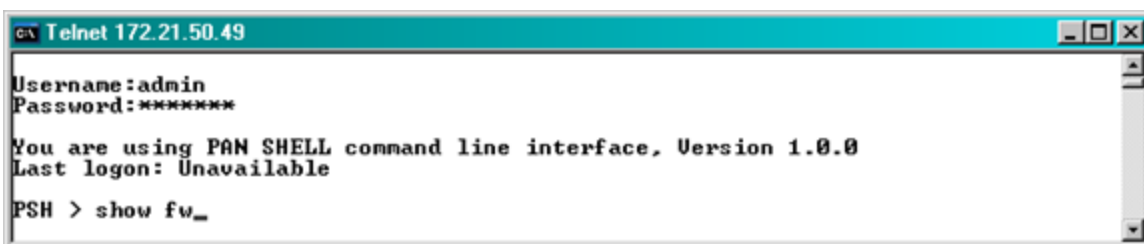
- At the PSH> prompt, enter:

show fw

The screen will display information pertaining to your firmware.

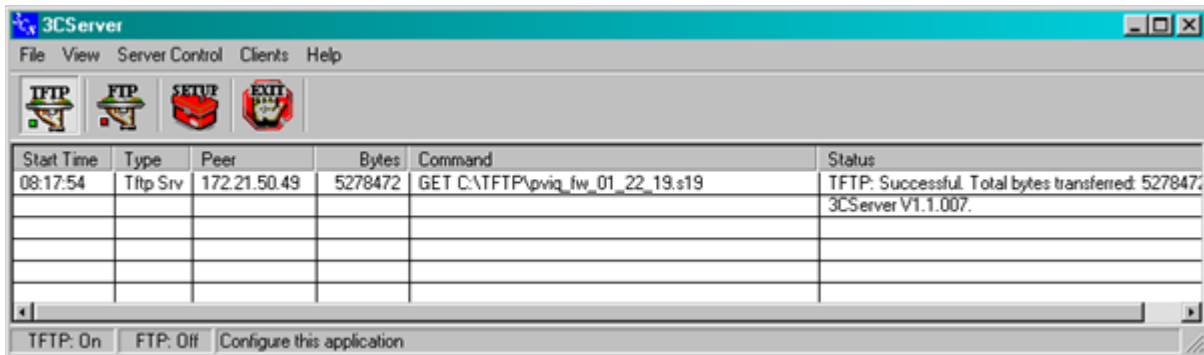
- Check to see that the Firmware update has been sent by the TFTP server. When the file transfer is complete, you will see a window similar to the following:

NOTE: The TFTP server process takes approximately 5 minutes, followed by an additional 30 minutes for the panel to be updated. During this time, it is common for the panel to experience various LED flashes and audible beeps from the panel.
