The Advantages Of A Varying Length Segmented Foil Tape In Category 6A UTP Cable

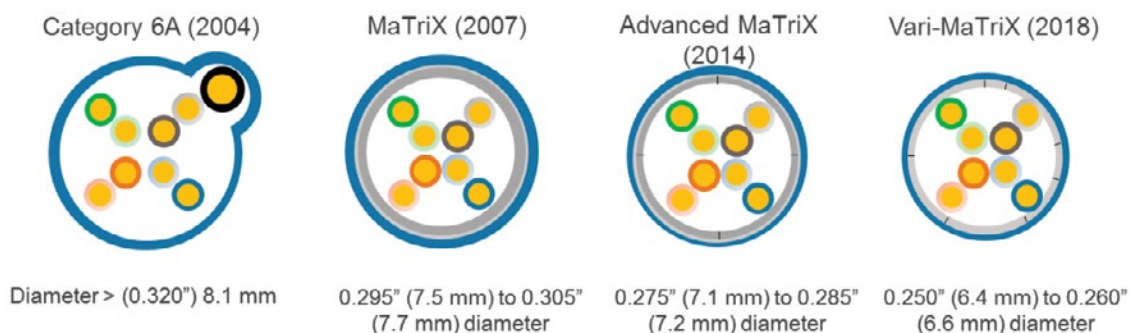
Figure 1. Category 6A Cable History at Panduit.

Size constraints of traditional Category 6A UTP (unshielded) cable designs are typically driven by the alien crosstalk requirement. With Panduit’s Vari-MaTriX design, the discontinuous metallic foil barrier provides far superior alien crosstalk performance, thereby removing the traditional constraints on cable size. Instead of alien crosstalk dictating minimum cable sizes, the Vari-MaTriX cable size is limited primarily by the wire gauge of the internal conductors. The result is a Category 6A cable similar in size to lower category cables and alien crosstalk performance superior to traditional UTP. The history of Category 6A cable sizes at Panduit is shown in Figure 1.

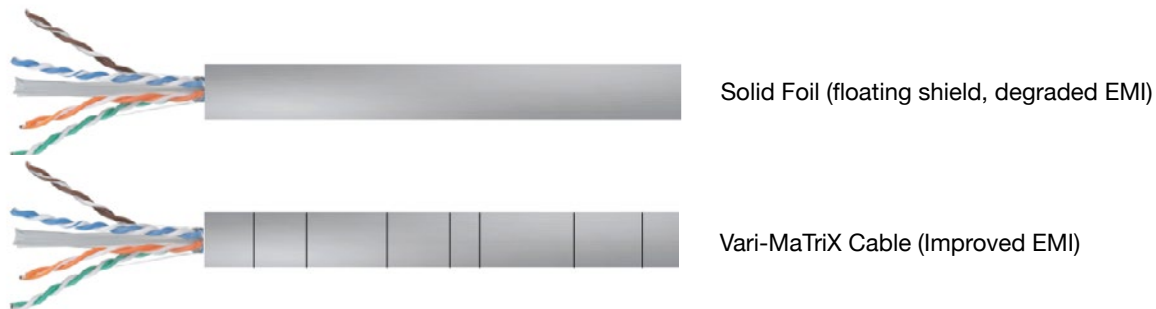
Figure 2. Example of Solid Foil and Vari-MaTriX Cable.

Others in the industry have since incorporated metallic barriers in their UTP cable designs to take advantage of the size and alien crosstalk enhancements. However, some of these cables implement a continuous foil barrier (floating shield) which can degrade the electromagnetic immunity performance of a system due to the foil being unterminated. Using this type of cable construction in a UTP channel equates to using an unterminated F/UTP shielded cable (foil around a twisted pair). Large foil discontinuities are created at each UTP jack and plug interface because the continuous shield does not get terminated. Some in the industry have incorporated discontinuous metallic barriers with fixed length discontinuous segments. While these designs may be an improvement over continuous unterminated foil barriers with respect to immunity, they can still be prone to specific in-band and/or out-of-band EMC weaknesses depending on the fixed length of the discontinuous segments. The discontinuous and variable length nature of the metallic barrier in Panduit's Vari-MaTriX cable prevents any degradation to the EMC performance of a system whether in-band or out-of-band. A comparison of the foil designs is shown in Figure 2.

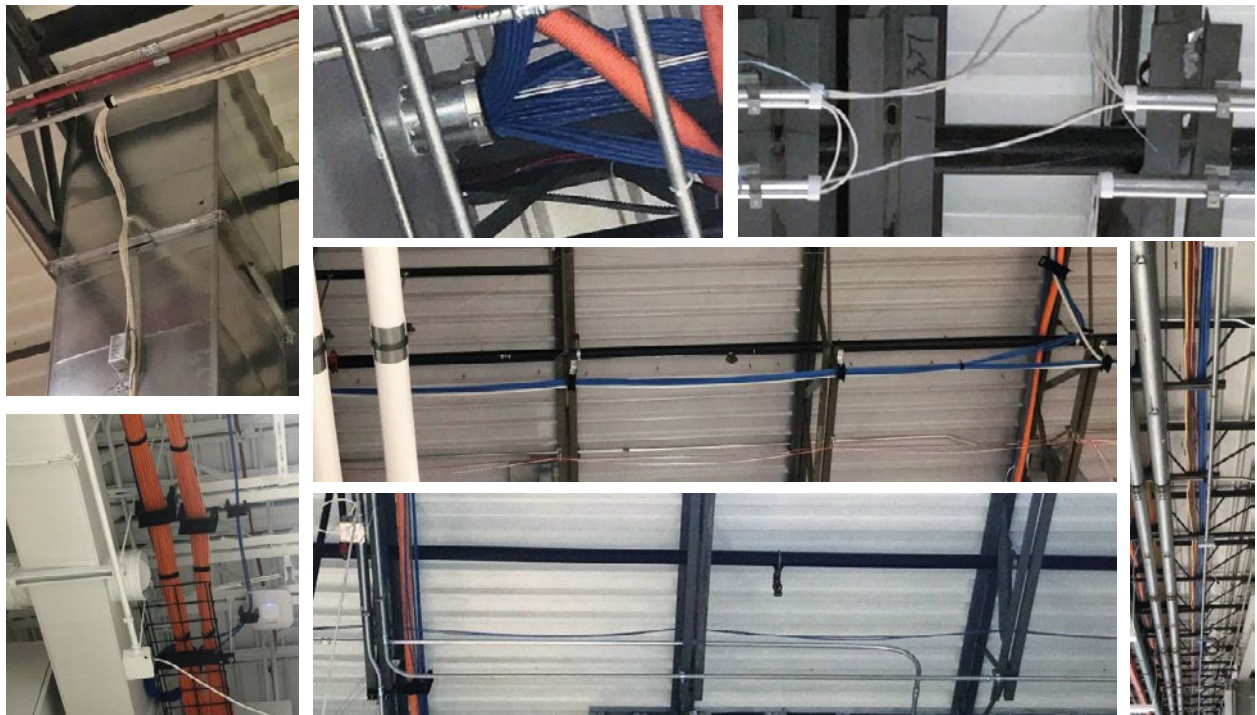
Figure 3. Example of metallic surfaces that can create impedance discontinuities.

Building an unshielded channel with unshielded plugs, unshielded connectors, and a cable which incorporates a continuous metallic outer foil essentially creates the worst-case scenario for shielded systems described on page 6. While networks can operate successfully with UTP cabling systems in the EMC environments found in enterprise and data center locations, implementing an unterminated shielded cabling system in those environments introduces new EMC weaknesses that can disrupt communication over the network. In the presence of EMI, current can be induced in the metallic foil surrounding the cable. Unlike the shielded systems where this current is shunted to ground due to the low impedance continuity of the shield throughout the channel, the induced current will be reflected at each UTP connector and/or plug interface where the continuity of the shield ends. Reflections will also occur at locations along the length of the cable where the common mode impedance of the unterminated shield changes. Metallic surfaces in close proximity to the cable will lower the impedance at these locations. Examples of these metallic surfaces are ladder racks, HVAC ducting, conduit, and structural beams as shown in Figure 3. These impedance changes will cause a portion of the induced current to be reflected at the location of the discontinuity.

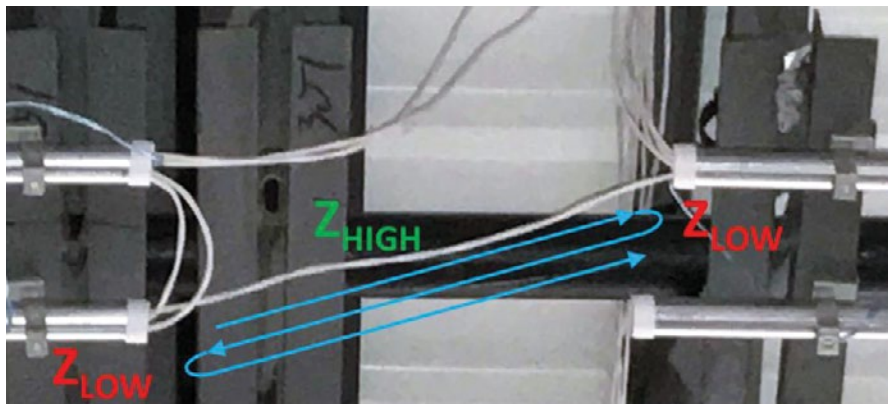
Figure 4. Impedance discontinuities creating a standing wave, example 1.

A standing wave can be built up by the current reflecting back and forth between at least two of these discontinuities. Like a dipole antenna, the combination of the successive reflections caused by the shield discontinuities will give rise to a standing wave at a frequency whose half wavelength is equal to the distance between the discontinuities. Figure 4 and Figure 5 highlight examples of where the impedance discontinuities and multiple reflections can occur. Nearby metallic surfaces such as equipment racks and cabinets can also act as a reference plane for the current induced on the metallic foil serving to enhance the resonant behavior of the unterminated foil. This standing wave on the unterminated foil will occur when the EMI incident on the cable is at or close to the aforementioned frequency. As a result, the unterminated shield can have voltage maxima and minima along the length of the foil between successive discontinuities. A corresponding noise voltage will be induced onto the conductors within the cable at the standing wave frequency due to the strong capacitive coupling between the foil and the conductors. Imbalances in the cabling channel will convert a portion of this noise into a differential signal, while the remaining noise will remain as a common mode signal. This mechanism by which noise couples into the cabling channel from a source of EMI is unique to those cables implementing unterminated foil barriers. Traditional UTP cabling channels will not be susceptible to this phenomenon in the same way because there is no unterminated conductor to support a standing wave.

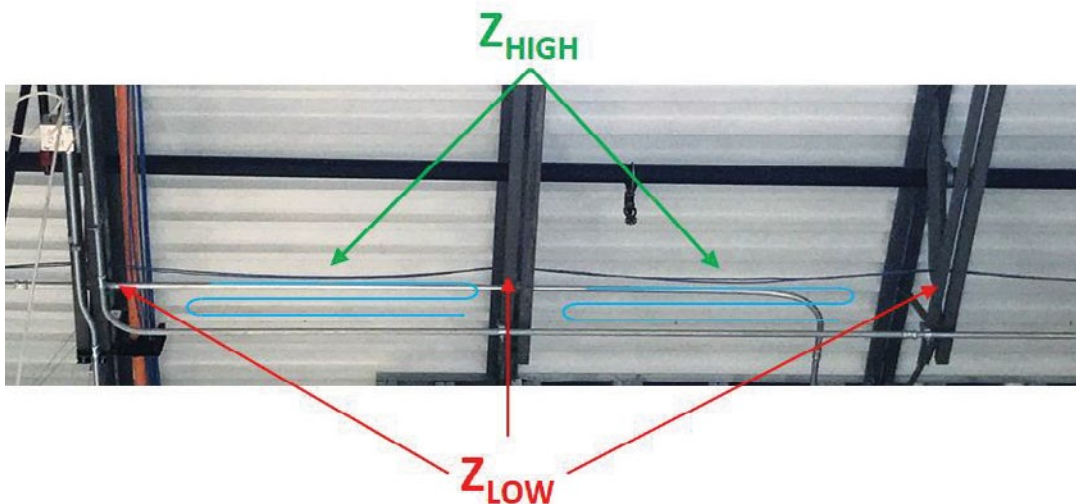
Figure 5. Impedance discontinuities creating a standing wave, example 2.

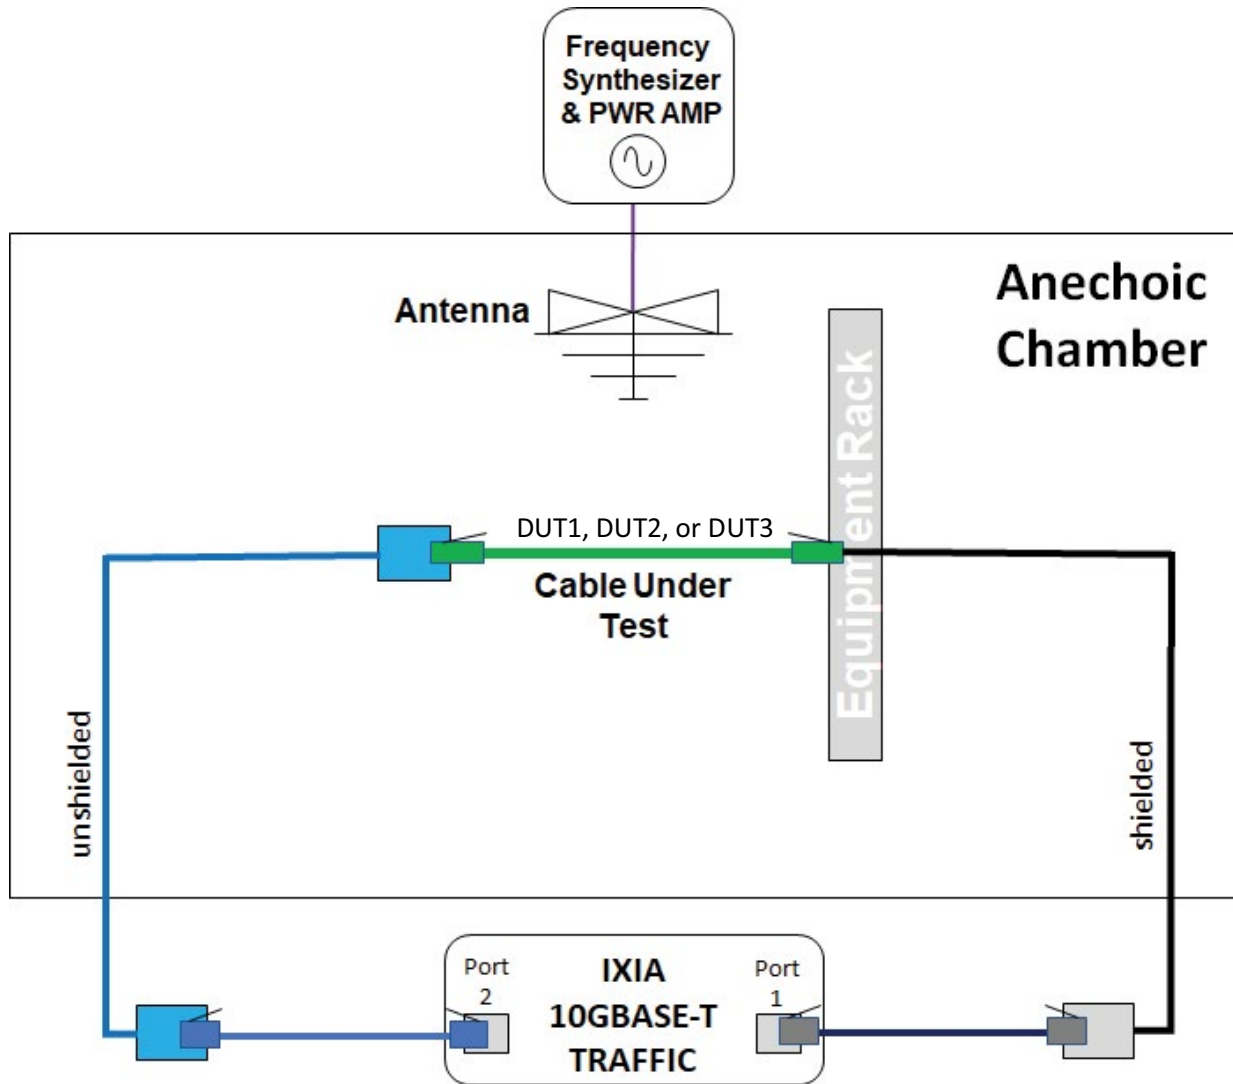
Figure 6. Test setup used for evaluating solid foil and Vari-MaTriX cable.

The test was configured to emulate one possible real-world application environment. Per Figure 6, an IXIA 10GBASE-T line card (LSM10GXM2GBT-01) was used to generate and monitor the 10GBASE-T traffic bidirectionally across the channel. One port of the IXIA traffic generator was connected to a shielded port on the equipment rack inside the anechoic chamber through shielded cabling. All shield connections from the IXIA box to the equipment rack in the anechoic chamber were continuous and properly terminated with best practices. This connection serves to bring the data source (IXIA) to the equipment rack without having to position the IXIA physically inside the anechoic chamber where it would be exposed to the EMI. The portion of the channel under test being exposed to EMI was then connected to the equipment rack.

The test was conducted by comparing the performance of 1m horizontal cables terminated with unshielded plugs (similar to a patch cord). In each scenario, the cable type was changed to be the types under evaluation (UTP cable with no foil, solid foil, and Vari-MaTriX cable). These devices under test (DUT) were connected to a UTP jack and 10m of UTP horizontal cable which was routed back out of the anechoic chamber. A 2m UTP patch cord completed the connection from the horizontal cable to the second port on the IXIA traffic generator as shown in Figure 6. The specific DUTs are:

- DUT1: 1m true UTP patch cord
- DUT2: 1m patch cord made with a floating unterminated foil around the conductors. In this configuration, there is a 1m length between shield discontinuities.
- DUT3: 1m patch cord made with the Vari-MaTriX cable which uses a metallic foil barrier with variable length discontinuities in the foil.

Using a signal generator, power amplifier, and log periodic antenna, the frequency and field strength of the EMI can be accurately controlled. Conducting the test in a fully anechoic chamber allows the polarization of the interfering signal to be controlled relative to the position of the cable under test. This is a key variable associated with EMI and impossible to predict in every real-world environment. The worst-case scenario arises when the electric field of the interfering wave is aligned with the position of the cable as the induced current in the cable will be maximized. During this experiment, the cable under test was positioned horizontally across a table to align with the horizontal polarization of the log periodic antenna. The fully populated equipment rack creates a metallic surface which will act as a reference plane for the current induced on the cable under test. The position and orientation of the DUTs exposed to the EMI and all other channel components was identical when testing DUT1, DUT2, and DUT3 to ensure an accurate comparison between the test conditions.

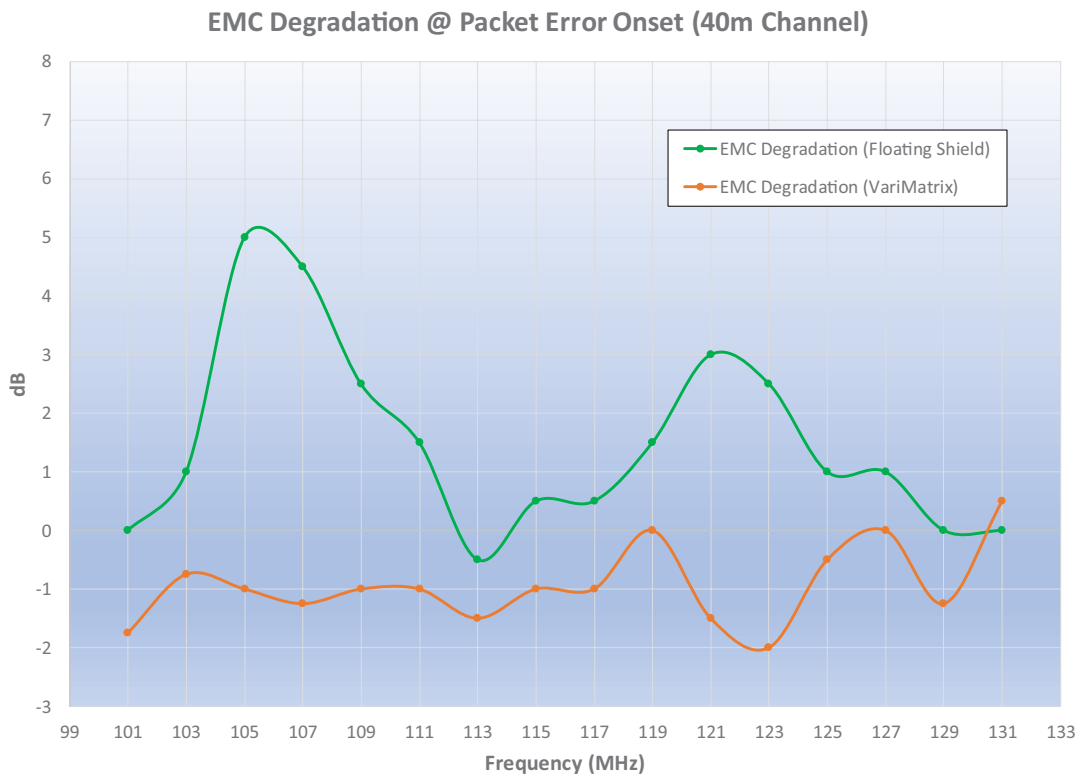
Figure 7. Floating Shielded vs Vari-MaTriX EMC Degradation at Error Onset, Device Under Test at 1m.

A comparison of the electromagnetic susceptibility between the three DUTs is plotted in Figure 7 and Figure 8 below. Figure 7 shows the EMC degradation at the onset of packet errors compared to traditional UTP cable for both floating shield and Vari-MaTriX cable construction. The maximum degradation of slightly more than 5dB was observed at approximately 105 MHz with DUT2 (Floating Shield). The half wavelength of a signal propagating on a cable at 105 MHz is approximately 1m. This is the exact length between discontinuities in the floating shield. Due to the standing wave induced on the floating shield by interference at 105 MHz, the susceptibility of the 10GBASE-T link was 5dB worse than the traditional UTP cable. Figure 8 shows the EMC degradation at link drop compared to traditional UTP cable for both floating shield and Vari-MaTriX cable construction. Again, at approximately 105 MHz the worst-case degradation of 6dB was observed with DUT2 (Floating Shield), demonstrating that unterminated foil degrades the susceptibility of the channel compared to traditional UTP. A 6dB degradation equates to a reduction in electromagnetic immunity by a factor of 2. In comparison, there was no EMC degradation with Vari-Matrix cable for either the onset of packet errors or the link drop condition.

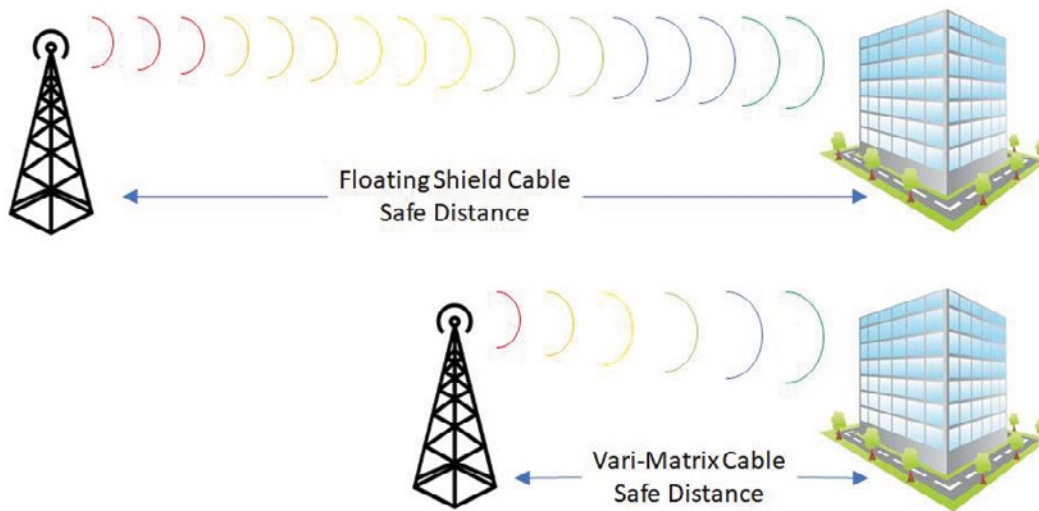
Figure 9. Vari-MaTriX EMC safe distance from EMI source reduced by 2X.

To translate this factor of 2 to a real-world example as shown in Figure 9, consider a source of EMI at 105 MHz, such as FM radio broadcast, that produces a safe level of EMI in a data center when it is located at least two miles away and Vari-MaTriX cabling channels are installed. If cabling with unterminated continuous foil barriers were installed, the safe distance to the FM broadcast tower would now be at least four miles (2X) away. The “safe” distance implies that even when all the variables involved with susceptibility align in the worst-case fashion, the network will not be affected by the interfering noise.

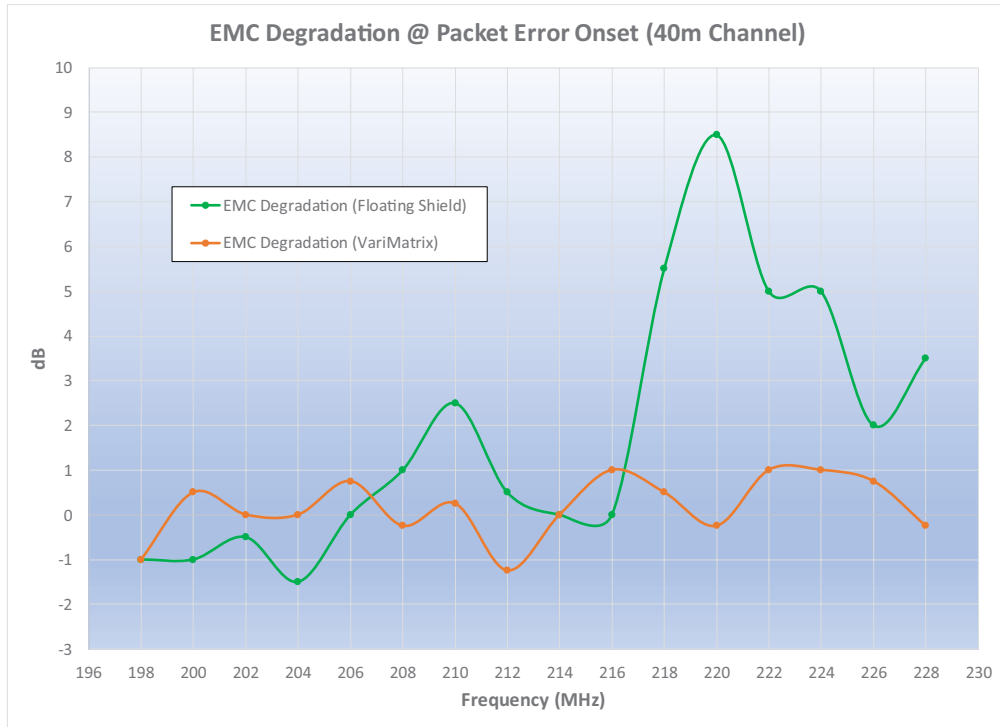
Figure 10. Floating Shielded vs Vari-MaTriX EMC Degradation at Error Onset, Device Under Test at 0.5m.

A comparison of the electromagnetic susceptibility between the three DUTs is plotted in Figure 10 and Figure 11. Figure 10 shows the EMC degradation at the onset of packet errors compared to traditional UTP cable for both floating shield and Vari-Matrix cable construction. The maximum degradation of 8.5dB was observed at approximately 220 MHz with DUT2 (Floating Shield). The half wavelength of a signal propagating on a cable at 220 MHz is approximately 1m. This is the exact length between discontinuities in the floating shield. Due to the standing wave induced on the floating shield by interference at 220 MHz, the susceptibility of the 10GBASE-T link was 8.5dB worse than the traditional UTP cable. Figure 11 shows the EMC degradation at link drop compared to traditional UTP cable for both floating shield and Vari-Matrix cable construction. Again, at approximately 220 MHz the worst-case degradation of 9.5dB was observed with DUT2 (Floating Shield), demonstrating that unterminated foil degrades the susceptibility of the channel compared to traditional UTP. A 9.5dB degradation equates to a reduction in electromagnetic immunity by a factor of 3. In comparison, there was no EMC degradation with Vari-MaTriX cable for either the onset of packet errors or the link drop condition. Just as in the previous example, this factor of 3 requires that the safe distance from an EMI source at 220 MHz is three times further when cables with unterminated continuous foil barriers are used compared to Vari-MaTriX cable or traditional UTP cable.

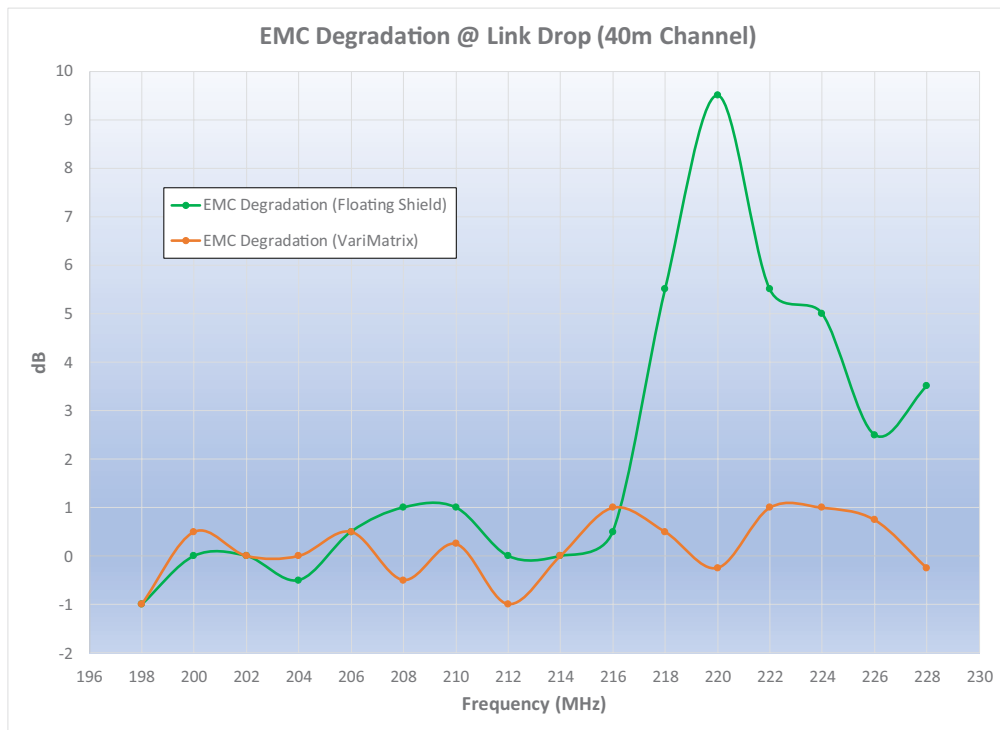
Figure 11. Floating Shielded vs Vari-MaTriX EMC Degradation at Link Drop, Device Under Test at 0.5m.
